XXII. *Proceedings relative to the Accident by Lightning at Heckingham.*

Report of the Committee.

PURSUANT to your resolution, appointing us a committee to examine the House of Industry at Heckingham in Norfolk, which had been struck by lightning although it was armed with conductors, we arrived there on the 21st of January. Seven months had then elapsed since the accident, yet we had the satisfaction to learn, that no material changes had been made in the conductors or the building in that period; some laths that had been burnt, some bricks and pantiles which had been damaged or thrown down, were replaced; but we found means to procure distinct information of those repairs from the workmen who had been employed to execute them. In order to communicate a clear idea of the accident, it will be necessary to premise a general account of the building; then to represent the manner in which the conductors were applied; and, lastly, to describe the stroke of lightning, with its effects.

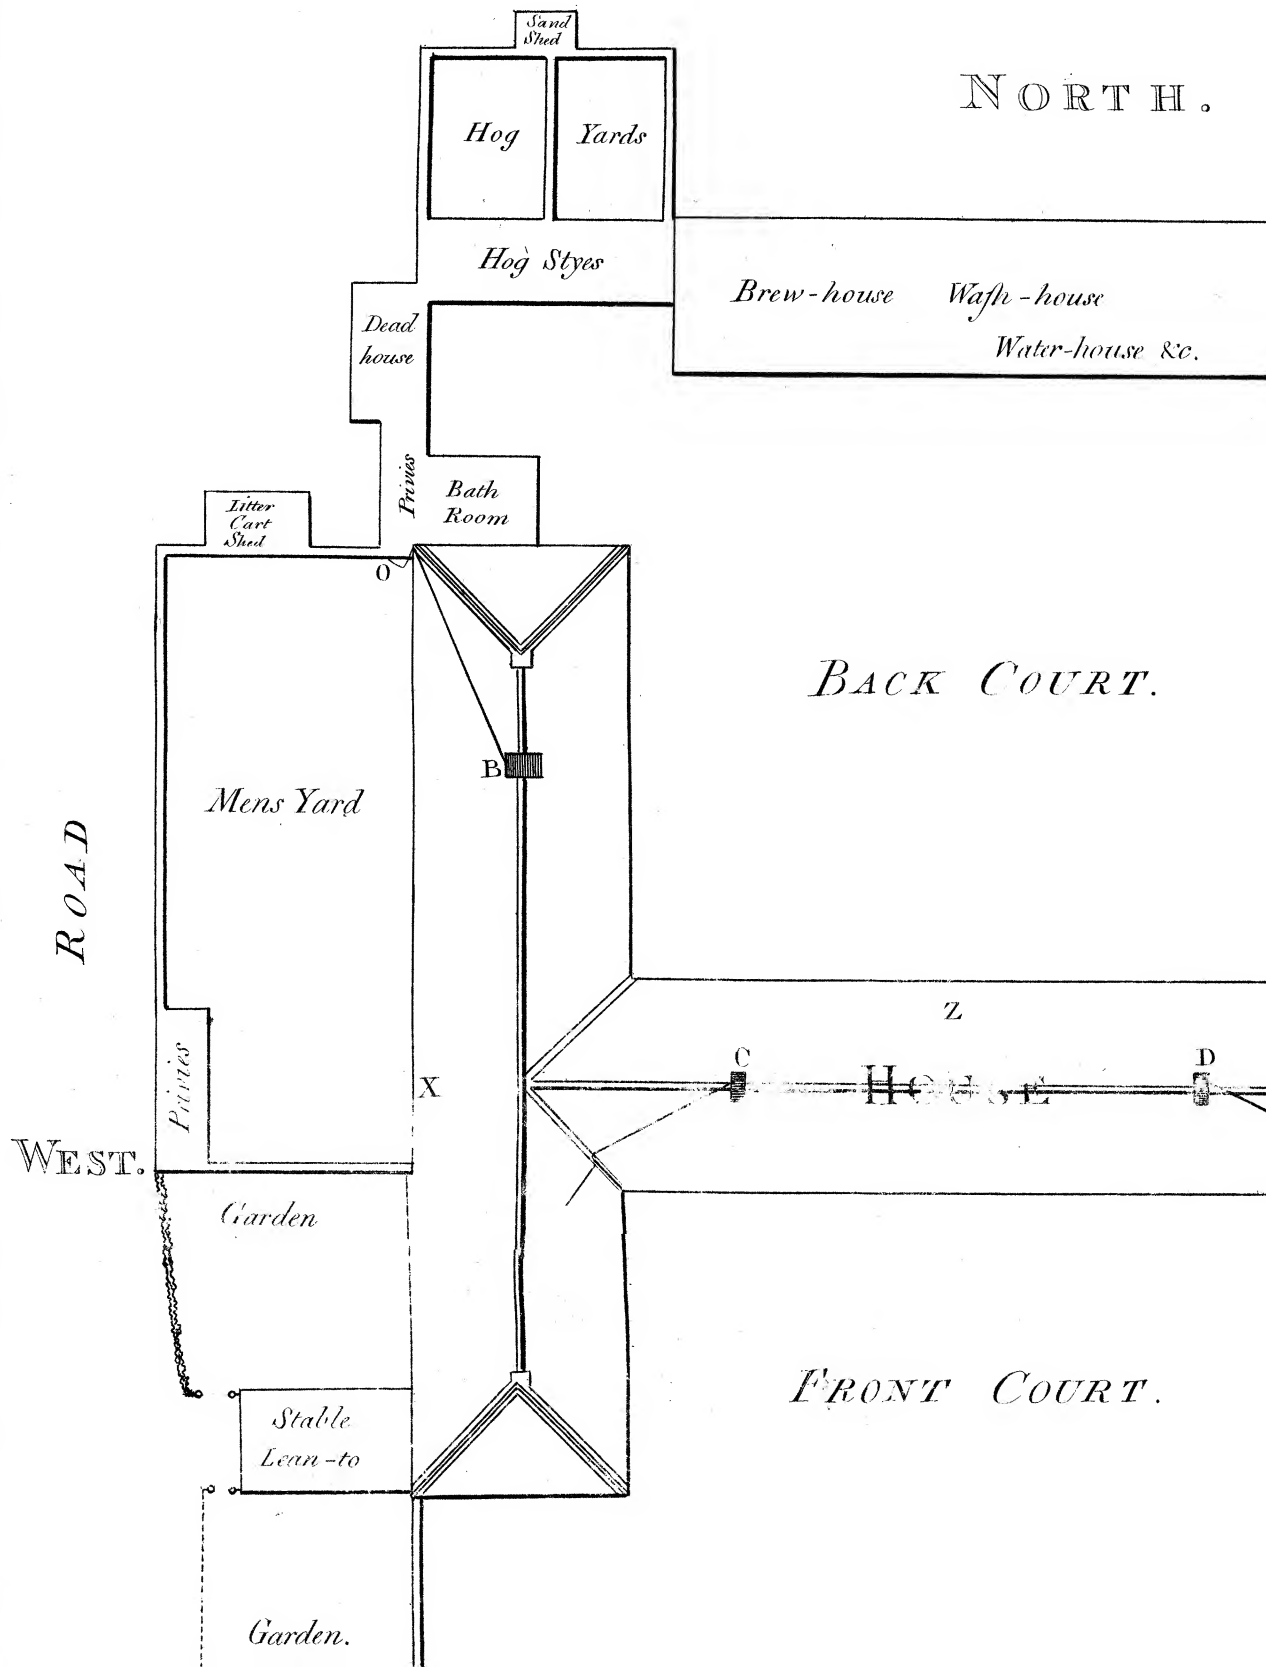
Fig. 1.

The general form of the building is that of the Roman letter H (see the general plan, fig. 1.), consisting of a center range (Z) and two flanks (Y and X). It stands on a gentle rising, which can by no means be termed a hill, with its front facing S. 9° W. To the western side of the west flank, and eastern side of the east flank, some lower buildings are annexed, serving as offices of different kinds; and there are two courts, one before and the other behind the house, together with some small gardens and yards on each of the flanks, in all of which stand various detached offices, as will be easily conceived from the general plan (fig. 1.).

Though there were eight of these conductors reaching above the chimnies, yet they had only four terminations below. For the conductors to the two chimnies D and E (fig. 1. and 2.) being continued toward each other along the roof, united in the valley over the lead gutter there (at L in the 1st, 2d, and 3d figures), and from that point only one conductor was continued down the valley toward the ground. In like manner the two conductors from the chimnies A and C (fig. 1.) united in the valley of the roof between them, and were carried down toward the ground as a single rod. All the three conductors from the chimnies F, G, and H, successively joined together (see M, N, fig. 1.), and only a single rod was continued from them down the lower part of the building. Lastly, the conductor from the chimney B (fig. 1.) went down single all the way, without having formed a junction with any other.

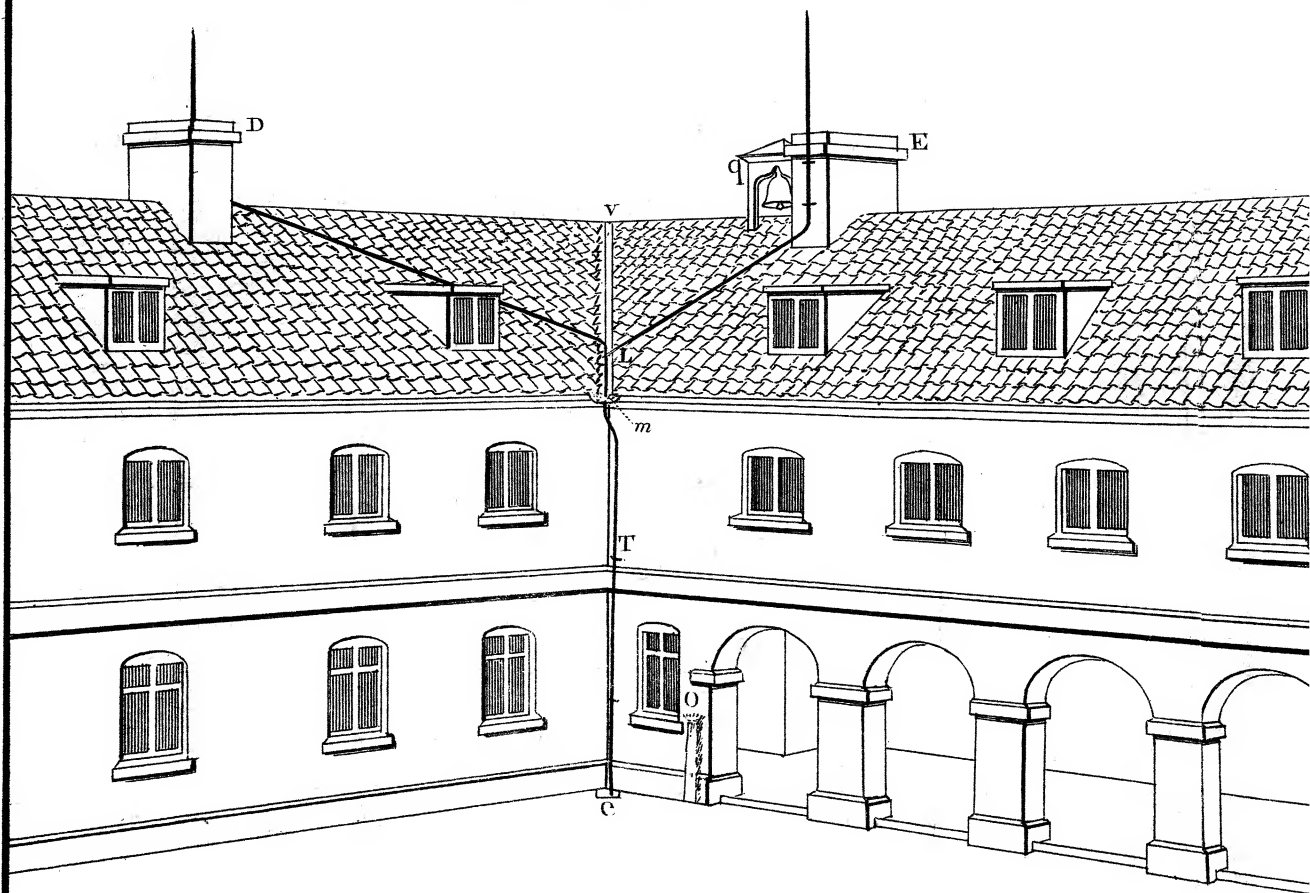
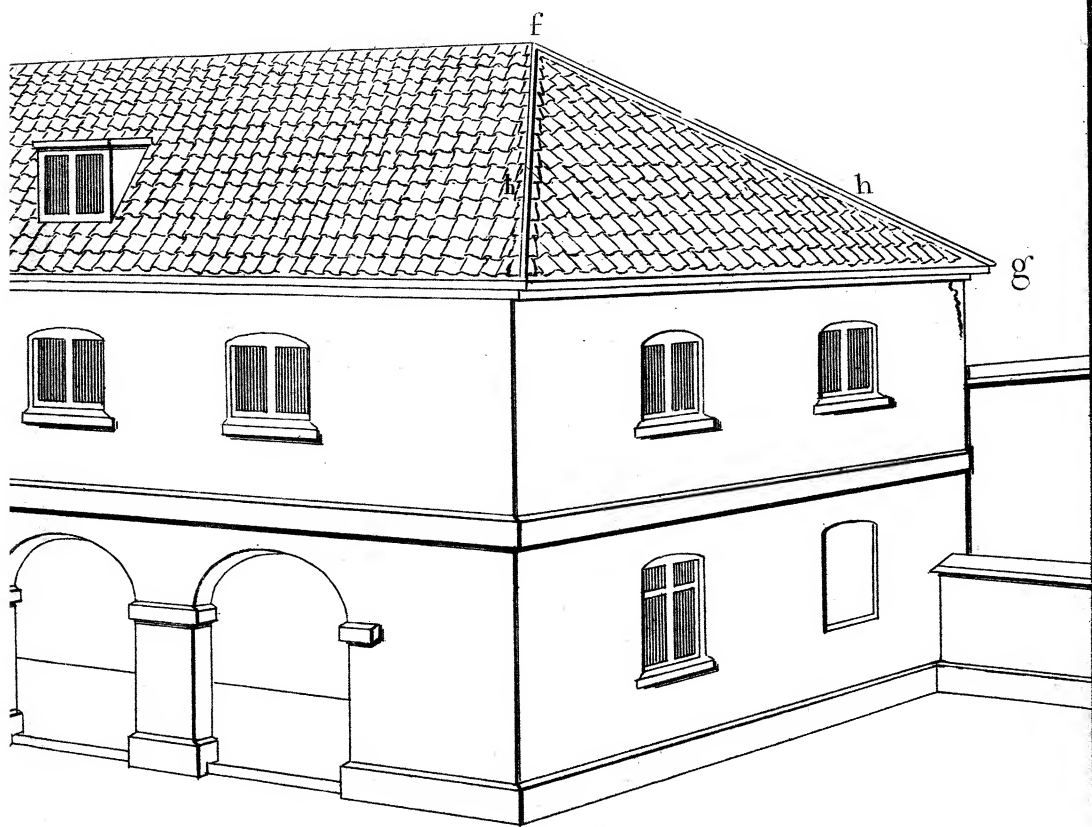
Fig. II.

Tracing the conductor downward from this point of union, we found it descend over the lead of the valley, to the surface of which it gradually approached, till at a hole made on purpose (*m*, fig. 2.) it passed through the lead, whence it was continued down the angle formed by the intersection of the east flank with the front of the center range (T, fig. 1. 2. and 5.). It no where touched the wall of the building, but was kept in its place by ring-staples (*p*, *p*, fig. 3.). Being arrived within two or three inches of the ground, it entered into a channel of brick, enclosed on all sides (at *e*, fig. 5.), in which it was continued down to the arch of the great drain of the fore-court (*x*, fig. 5.); here, having passed through a hole in the haunch of the arch (*y*, fig. 5. and 7.), it was bent off from the house through the middle of the drain, and

Having examined all the marks that appeared between the bottom of the stricken hip and the ground, our next inquiries were directed to the top of the hip (*f*, fig. 2. 3. 4. and 11.). Here the upper plate of lead (*e*, fig. 4.) which served as a capping to the junction of the hip with the ridge of the roof, being taken off, we found, on its under surface, three distinct marks of fusion ; and on the upper surface of the sheet of lead which it covered three corresponding marks, so exactly similar, that the two surfaces of lead seem to have touched one another in a melted state. These fused spots are just in the bend of the
lead,

As both extremities of the hip, therefore, were, in some degree at least, affected by the lightning, we proceeded to ascertain their distances from the nearest conductor, which was that affixed to the chimney E (fig. 2. and 4.). Having determined the necessary measures, and calculated the hypotenuse, the distance from the point of the conductor to the beginning of the lead on the top of the hip (*e*, fig. 4.) came out 42 feet and a quarter; thence to the bend where we found the marks of fusion (from *e* to *f*, fig. 4.) was five or six inches more; and as the hip measured about 27 feet in length, the distance from the conductor to the bottom of the hip (*g*, fig. 4.) may be called 69 feet. From the top or bottom of the hip, to the nearest part of the conductor as it ran downward, the distances were not a foot less than these measures. We then took down the uppermost rod of the conductor, and carefully examined it, especially at the point, and at the hook and screws by which it had been joined to the second rod; but could nowhere discover the least mark of fusion or other injury. At the bottom of this conductor, however, where, having joined that from the chimney

Close to the chimney E, a dinner-bell hung in a common frame (q, fig. 2. and 4.). Three different persons went up to examine this bell; but could not discover upon it any where the least vestige of the lightning.

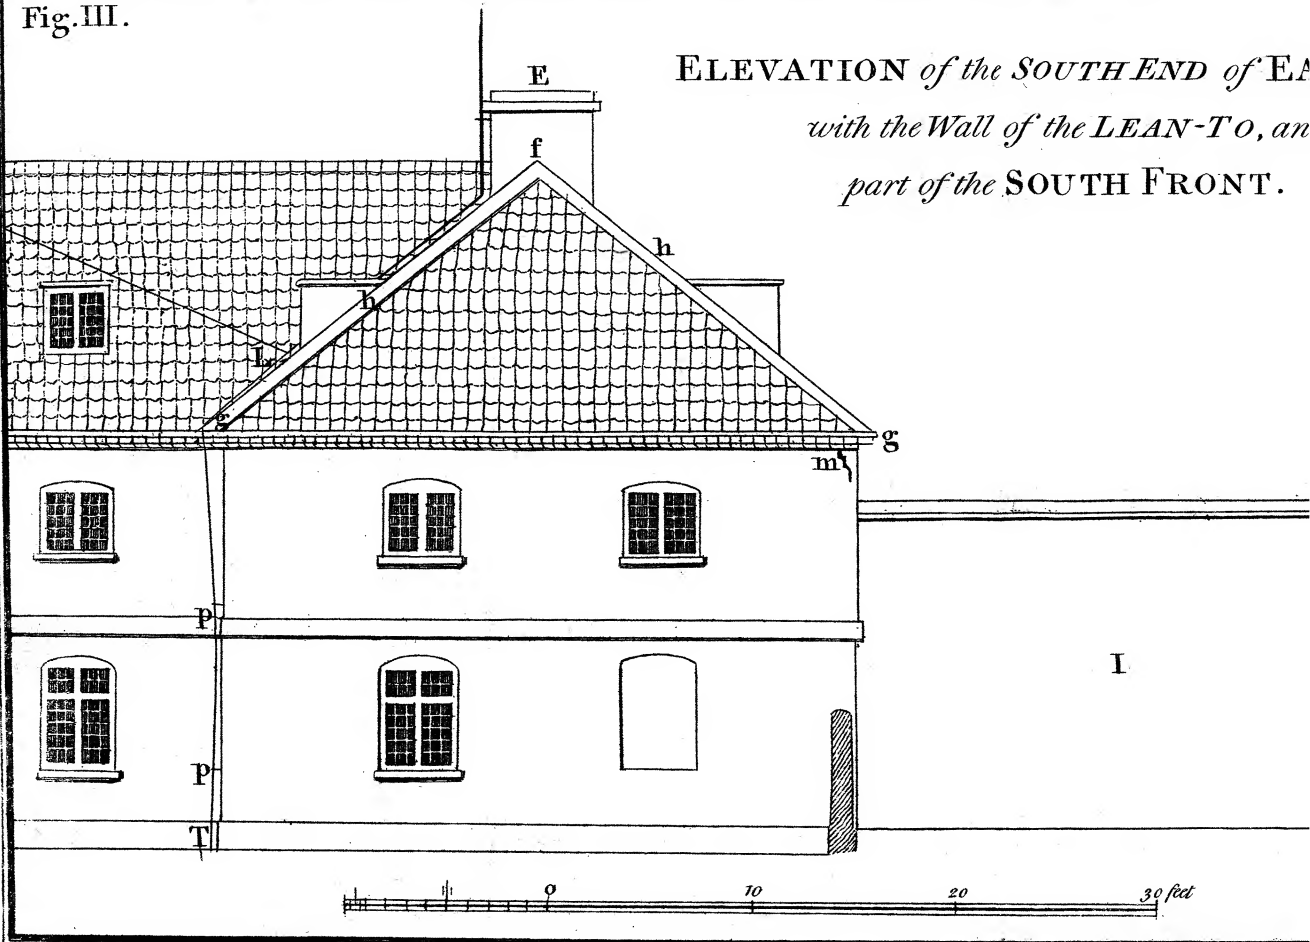
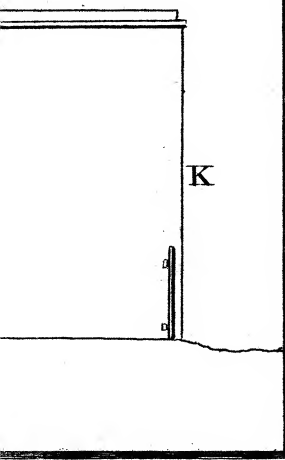
Fig. III.

Under this end of the wall-plate there was a crack in the south face of the corner (*m*, fig. 8.), which went down four courses of bricks, and then terminated abruptly (*m*, fig. 3.). The three external courses of bricks above this crack were new, and projected out much farther than the others, to form the cornice of the wall. Whether the bricks of the old cornice had been damaged or thrown down by the stroke, we could not learn with certainty; but the general report among the people we consulted was, that they had not, and were only taken down to extinguish the fire: this opinion seemed probable from the want of marks on the hip-pole which projected out with the cornice, and the appearance of such strong effects of lightning on the wall-plate which lay within any part of the projection; whence it might be concluded, that the lightning passed within the cornice, and no where through it. Between the bottom of the wall-plate, and the top of the crack where it appeared to begin at the foot of the cornice (*m*, fig. 3. and 8.), lay two inner courses of bricks (*o* and *p*, fig. 8.) covered by the cornice. Some damage had evidently been done to the bricks in this part, though we could not distinctly trace the progress of the lightning through them.

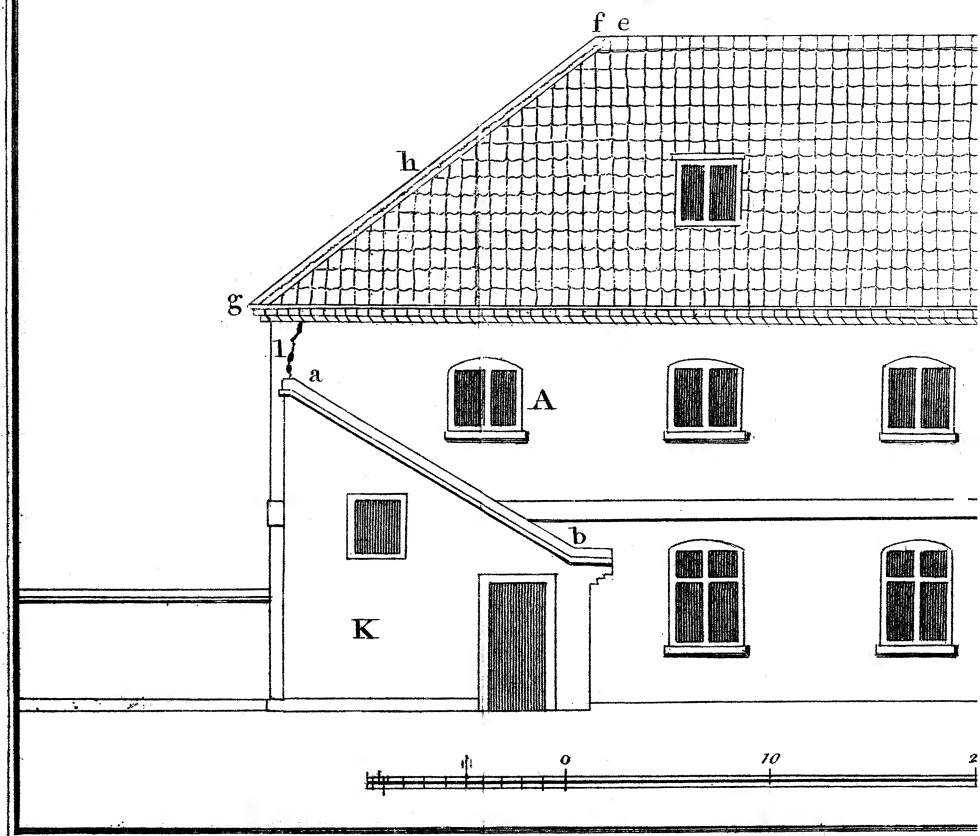
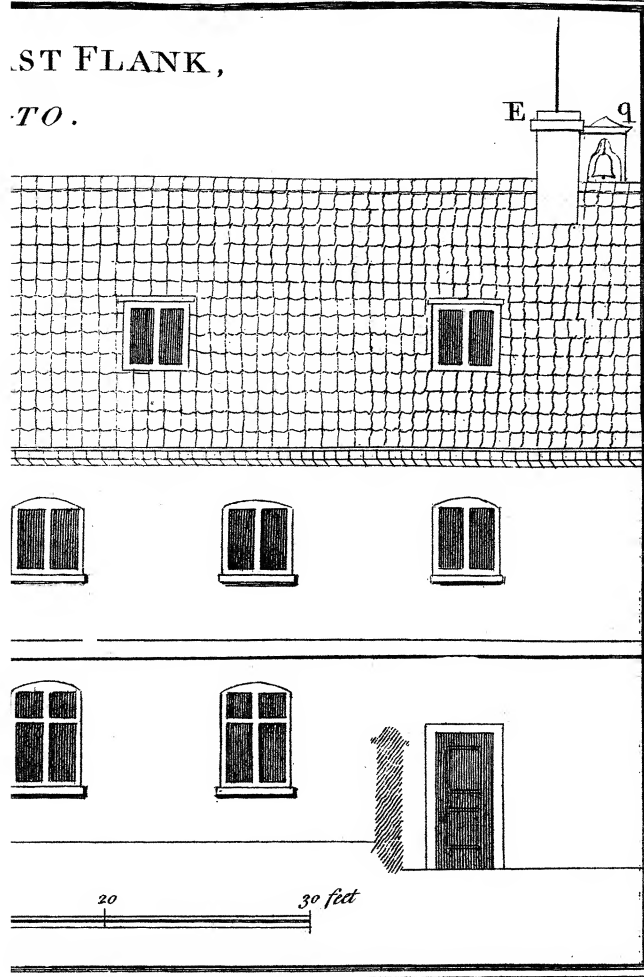
Fig.IV.

Beneath the east edge of the wall-plate, and separated from it in like manner by two courses of bricks, a similar crack descended from the bottom of the cornice (*l*, fig. 4. and 8.) on the east face of the corner, and went through ten courses of bricks till it reached the top of the wall that supported the stable. Here the three bricks next the house, it is said, were shivered into pieces as small as nuts, but not thrown off (*c*, fig. 10. and 11.). The cracks in the bricks on both faces of the

About seven feet from the stricken corner of the building, and almost two feet from the nearest part of the roof of the stable, is a window (A, fig. 4. 10. and 11.) being the southernmost of the upper range on the east face of the flank. It has thirty small panes of glass, set in lead. We were informed, that about half of these had been broken by the accident, chiefly on the side next the corner ; and that the fissures ran in general horizontally, nearly parallel. Very little, if any, of the glass was forced out. As we could not discover any trace of the lightning directly toward this window, a suspicion arose, whether it might not have been broken rather by the general concussion than by any immediate stroke.

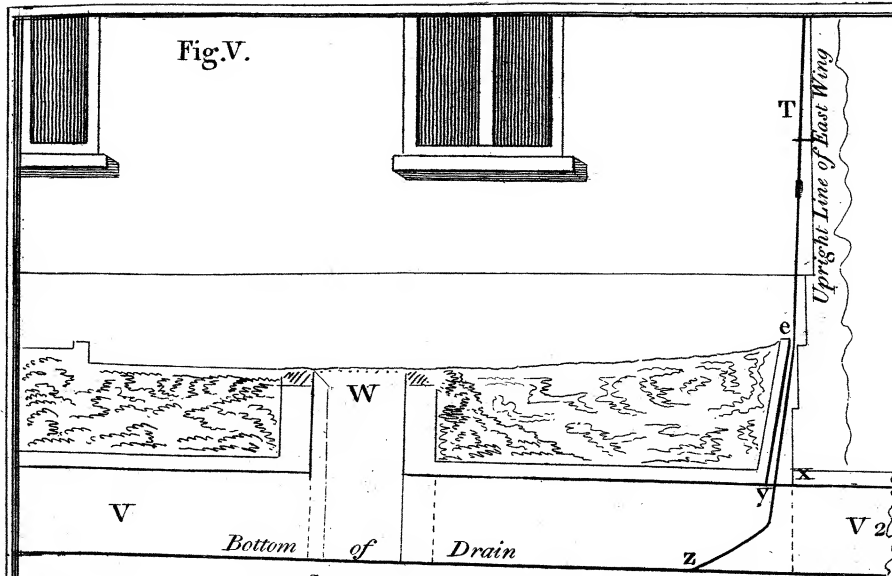
Fig.V.

ultimately terminated in contact with the bricks at the bottom of it (at *z*, fig. 5. and 7.). This conductor, therefore, in its passage downward, did not communicate, till it reached the bottom of the drain, with any thing better able to carry off electricity than masonry or timber; for the iron-staples fastening it to the wall, and the lead lining the valley, were themselves in contact with such substances only.

D, it terminated in the drain (see the general plan, fig. 1. and 2, fig. 5.), a small bright spot appeared on one of the angles. As some suspicions were entertained, whether this mark might not have been occasioned by the lightning, we cut off the end of the rod, and have brought it hither for public examination.

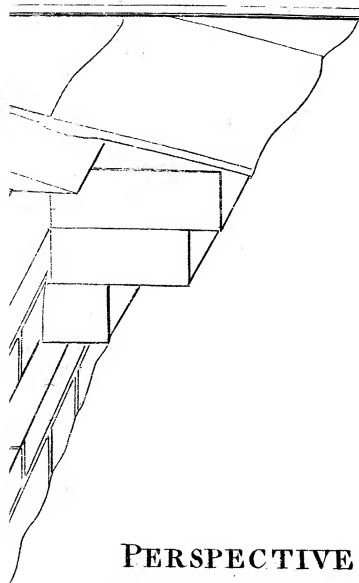
Fig. VIII.

driven into the timber making the tie of the angle, through the bevelled end of the hip-rafter, just without the part where the tenon of the latter is received into the mortise of the former (*a*, fig. 8.). Here it was that the fire seemed to have begun, though neither the holdfast itself, nor the hip-pole resting upon it, shewed any signs of the lightning. From the place into which this holdfast was driven (*a*, fig. 8.) to the outer end of the angle tie (*b*, fig. 8.) there was a considerable loss of substance, occasioning a large hole; but the sides of the hole within were so smooth, and so little charred, shewing plainly the grain of the wood, that it was scarcely possible to suppose the whole had been *burnt* out; we conjectured, therefore, that a large splinter had been forced off by the lightning at this place, and, in the same moment, the tenon of the hip-rafter set on fire where it enters the mortise. Indeed, unless some opening had been made by forcing out such a piece, it does not appear how the fire could have burnt, for want of air, in a part that is always so closely joined by builders: and yet, in this confined place, the tenon of the hip-rafter was so far consumed, that a ruler could be thrust in, almost to the further extremity of the mortise. From this spot the flame seems to have issued out eastward, between the tie of the angle and the wall-plate (*c*, *c*, fig. 8.) scorching all the timbers it could reach, and setting fire to the laths; but the mischief it had done was very trifling (see fig. 8.).

Just beneath the abovementioned hole at the end of the angle-tie (*b*, fig. 8), is the extremity of the wall-plate which lies upon the eastern wall of the east flank (*d*, fig. 8.). The end of this wall-plate was rent in a remarkable manner (*e*, *e*, *e*, *e*, fig. 8.), and several of the fissures were continued some way upon the sides (*d* and *f*, fig. 8.). Though the other timbers we have

mentioned are of fir, the wall-plate is of solid oak; and the violence done to its extremity was such, that we could not doubt but it had been occasioned by the lightning.

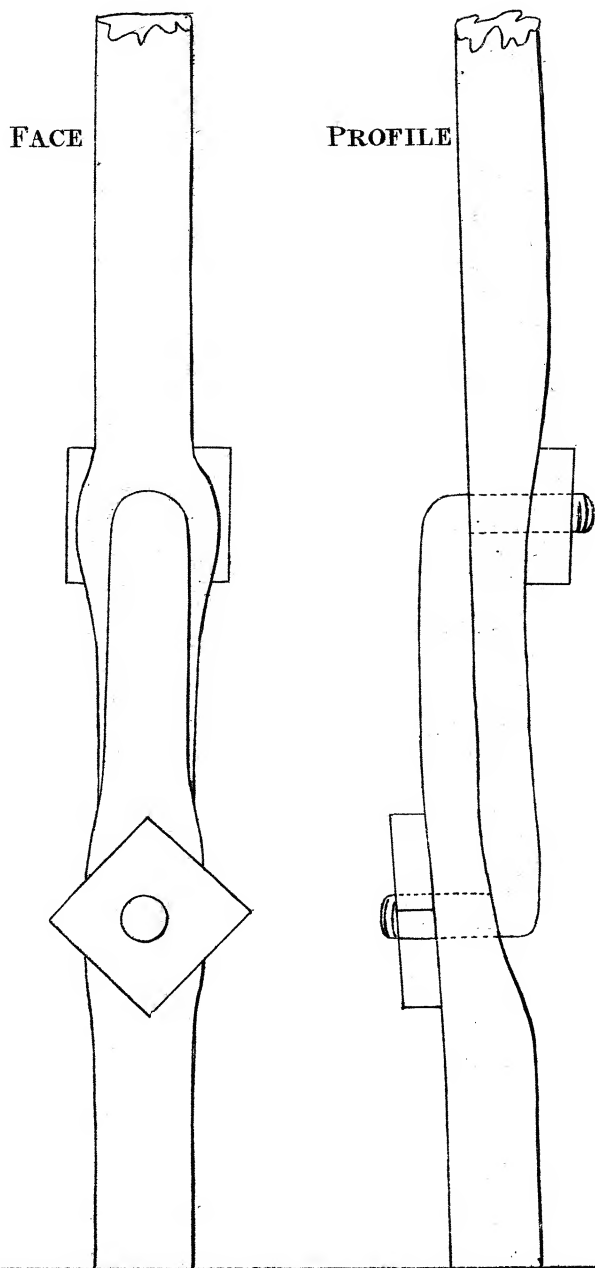
Fig. XII.

just rounded off. These conductors were continued down the building by a succession of similar bars of iron, in general from six to eight feet long, joined to one another by two hooks and nuts (see fig. 12.); that is, the corresponding ends of each bar being formed into a hook bent at right-angles, the hook of the uppermost went into a hole of the lowermost, where it was fastened with a nut, and the hook of the lowermost went into a similar hole of the bar above, where it was fixed in the same manner; the length of each of these joints, from nut to nut, was about two inches.

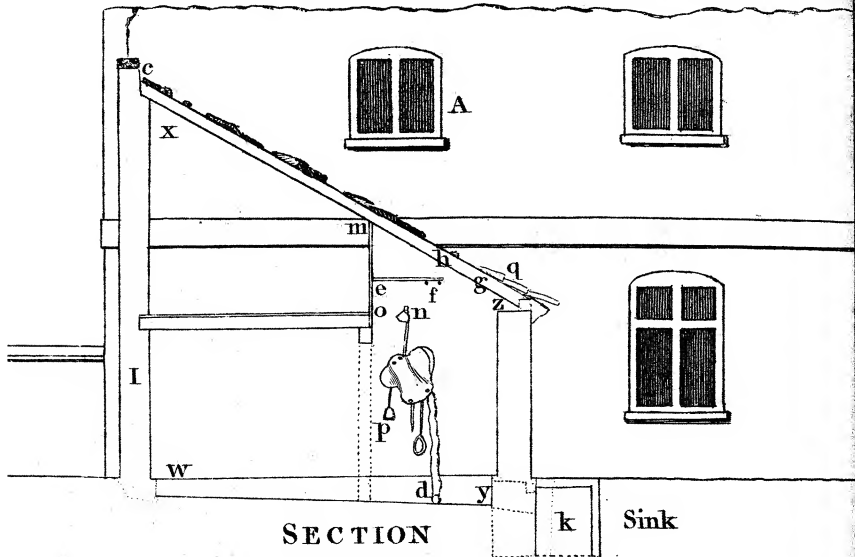
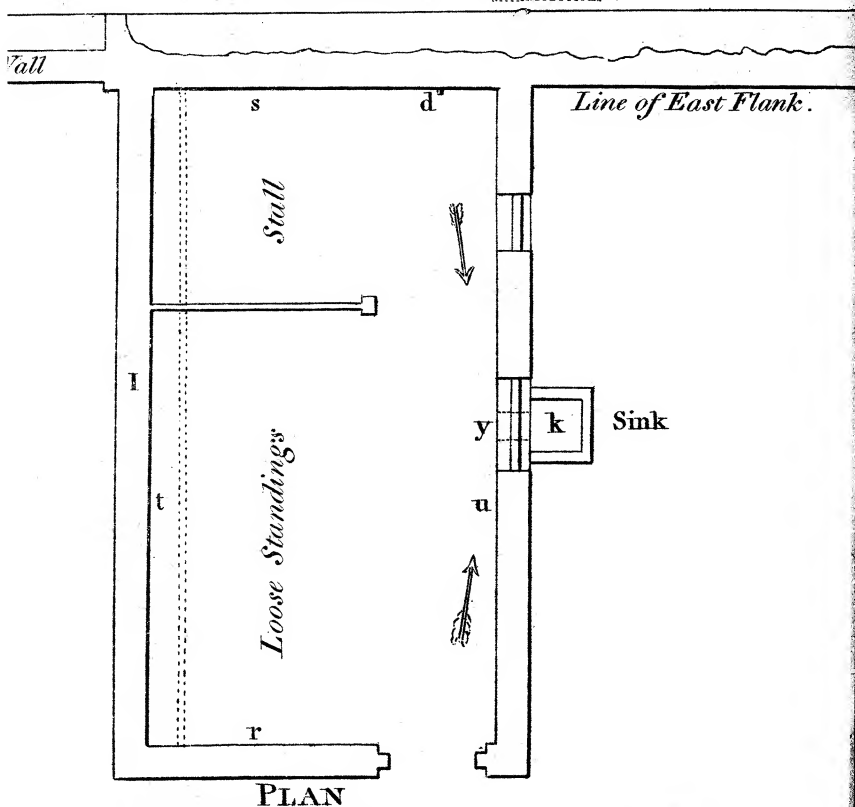
Fig. IX.

The stable in its inside is 25 feet long (from *r* to *s*, fig. 9.), 13 feet broad (from *t* to *u*, fig. 9.), 15½ feet high on its south side (from *w* to *x*, fig. 10.), and 7½ feet on the north (from *y* to *z*, fig. 10.). At the west end is a stall for one horse (*s*, fig. 9.). Near the middle of the north wall is a drain (*y*, fig. 9. and 10.), which terminates just without the wall in the garden (*k*, fig. 9. and 10.). Against the west end of the stable, a shelf (*e, f*, fig. 10.) was supported by two nails underneath (*f*, fig. 10.). Seven inches and a half below this shelf was a nail, on which the saddle hung by one of its stirrups (*n*, fig. 10.). The breadth of the shelf was near one foot and an half; its length

From the quantity of rain which fell in the thunder-storm, the stable was overflowed with water, which gradually sunk into the drain (at *y*, fig. 9. and 10.). The leather stripped off the seat of the saddle was found in the stable near this drain; whether thrown there originally, or carried by the water, is uncertain. From the point of the floor immediately under the saddle, to the nearest part of the drain, was about $12\frac{1}{2}$ feet; the width of the drain (*y*, fig. 9.) 14 inches; its length through the wall to the edge of the hole or sink into which it discharges itself 18 inches, and the depth of the sink from the bottom of the drain about one foot and an half. As this sink was merely a hole, without any drain leading *from* it, and was bricked at the sides, the water could not pass off by the drain of the stable any faster than it could soak through the loose soil at the bottom of the sink. And it is evident, from this construction, that the earth under the sink will usually be some of the wettest near the building, and be impregnated with salts from the stale of the horses.

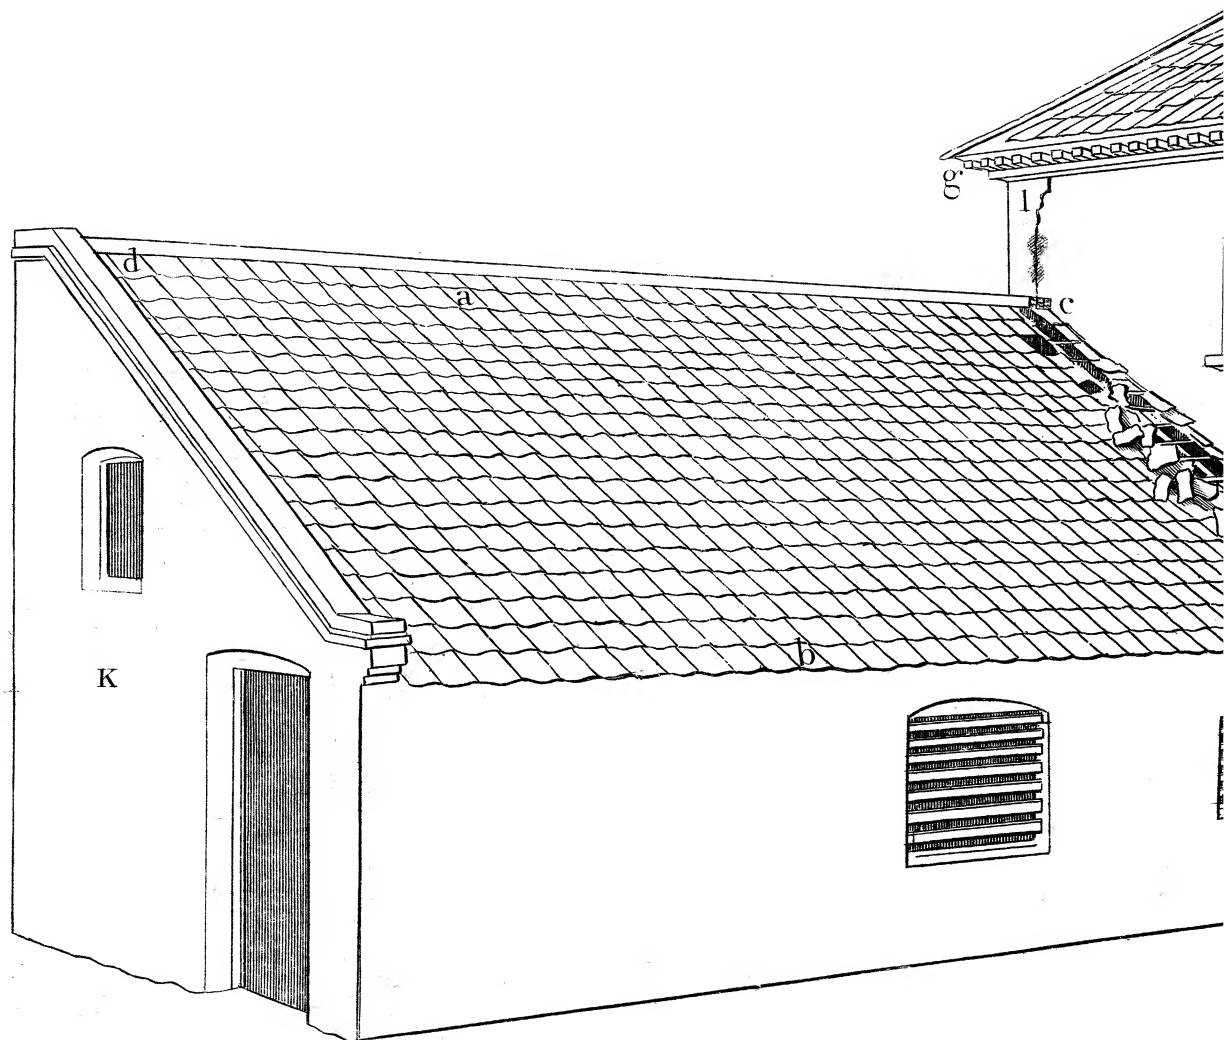
Fig.XI.

Beginning from these three shivered bricks on the top of the wall, three courses of pantiles on the roof of the stable, in the direction downward, were in great measure broken or displaced, except about two feet of the lower end of the courses, near the eaves, where the tiles remained untouched (see *c, m, g, q*, fig. 10. and *c, q*, fig. 11.). All these pantiles rested upon laths, which were fastened to the rafters of the roof by iron nails about eleven inches asunder. Within the stable, and almost underneath the spot where the damage to the pantiles ceased, a saddle hung, at the time of the accident, by a nail driven into the wall at that west end of the stable, which was also the eastern wall of the east flank of the house (*n*, fig. 10.). As this saddle, being much torn by the lightning, seems to have been the step by which it passed through the stable, the respective situations of all their parts shall be minutely described.
